SUMMARY

Tulsa, OK 74133

Noe Vazquez
OK License #70002512
Welcome Home Inspections LLC
5393451569
welcomehomeinspectionsok@gmail.com

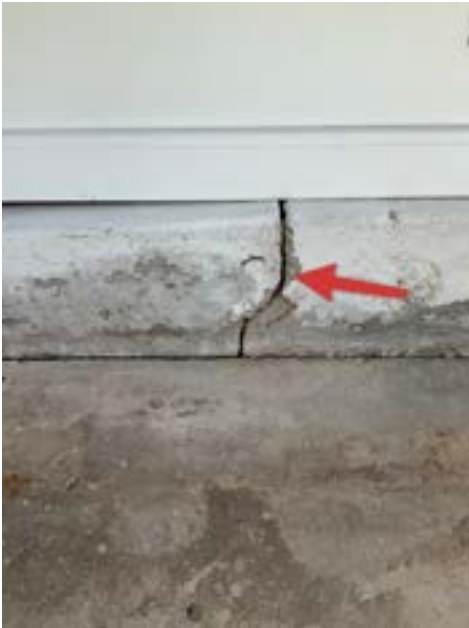
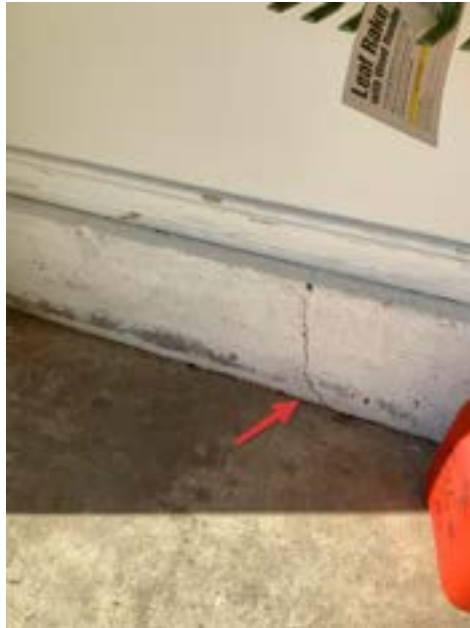
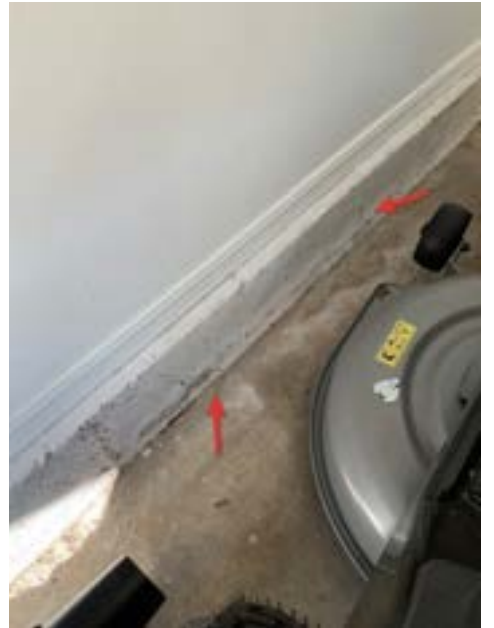
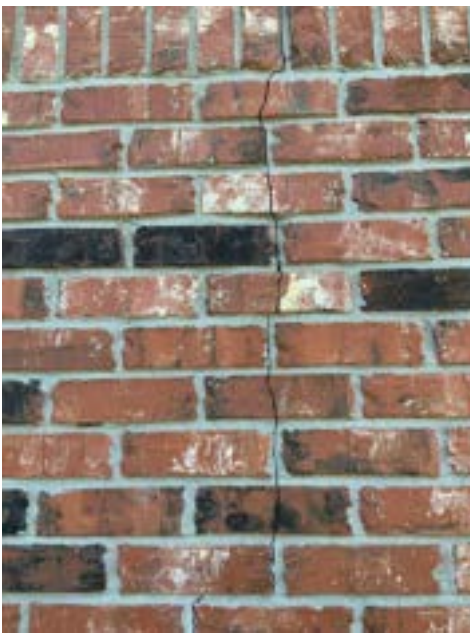
FOUNDATION CRACKS - MAJOR

Moderate to severe cracking noted at the foundation, exterior brick veneer, and evidence of interior drywall patches. Any cracks with a width greater than a thickness of a quarter is typically consistent with soil movement and could lead to serious damage to structural components, foundation and/or slabs. Recommend property owner to have a structural engineer evaluate and provide a report on course of action and remedy.

Contact a qualified structural engineer.

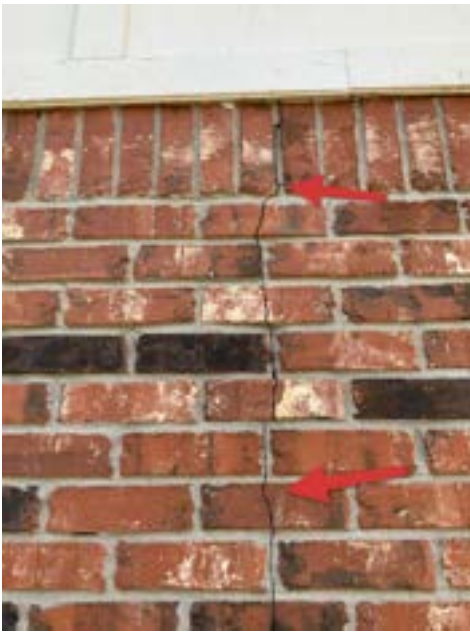
CRACKS - MAJOR

Moderate to severe cracking noted at the foundation, exterior brick veneer, and evidence of interior drywall patches. Any cracks with a width greater than a thickness of a quarter is typically consistent with soil movement and could lead to serious damage to structural components, foundation and/or slabs. Recommend property owner to have a structural engineer evaluate and provide a report on course of action and remedy.

Contact a qualified structural engineer.

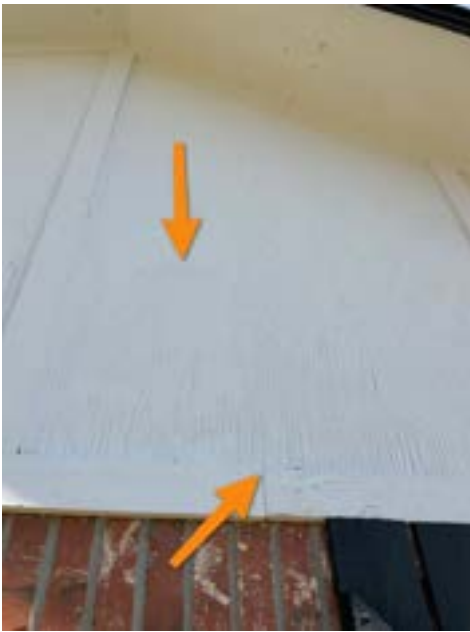
EVIDENCE OF WATER INTRUSION/PAINT DETERIORATION

Siding and trim showed signs of water intrusion and paint deterioration. This could lead to further siding deterioration and/or mold. Recommend a qualified siding contractor to evaluate and repair/replace all siding and trim that show signs of water intrusion and deterioration.

Contact a qualified siding specialist.

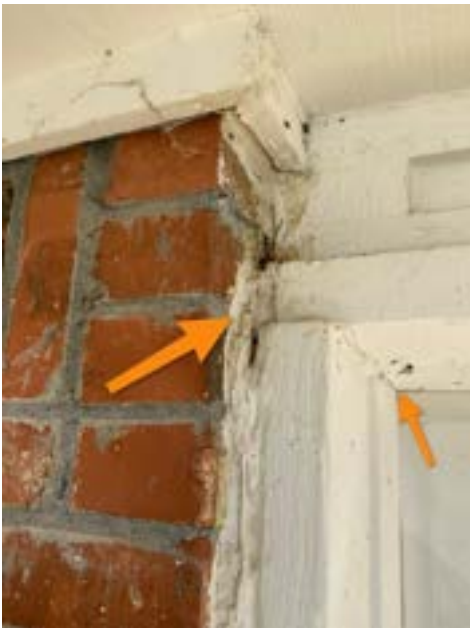
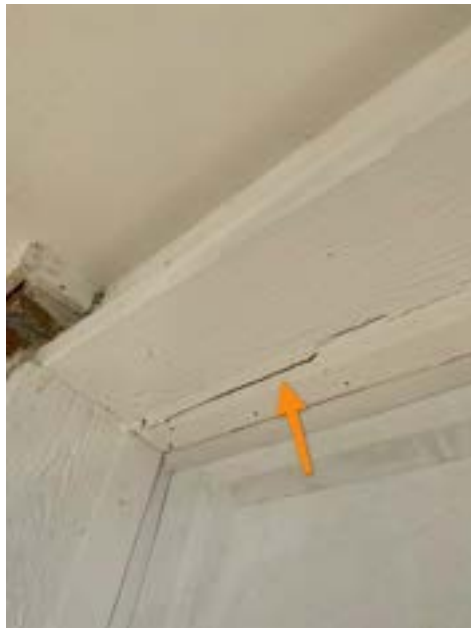
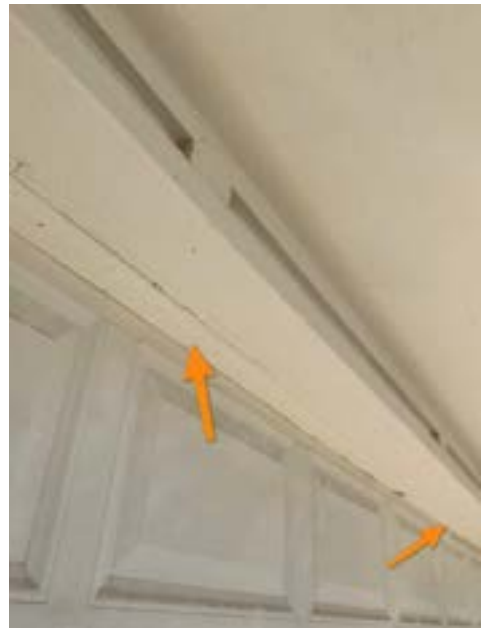
DAMAGED SIDING

Observed some damaged to the garage siding above the opening. Recommend a qualified professional siding contractor to repair/replace to help mitigate pests/insects and water intrusion.

Contact a qualified siding specialist.

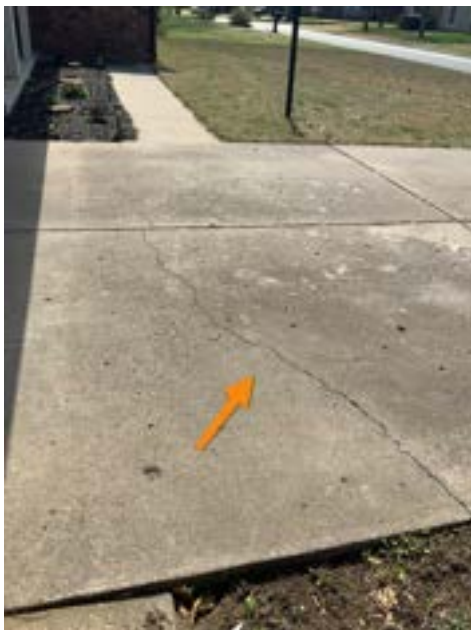
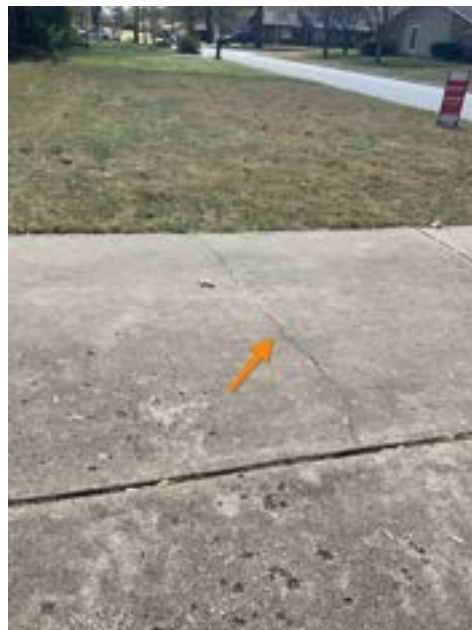
3.3.1 Walkways, Patios & Driveways
DRIVEWAY CRACKING - MINOR

Minor cosmetic cracks observed, which may indicate movement in the soil or heavy traffic in the area. Recommend a qualified concrete contractor to patch/seal all cracks and monitor thereafter.

Recommendation
Contact a qualified concrete contractor.

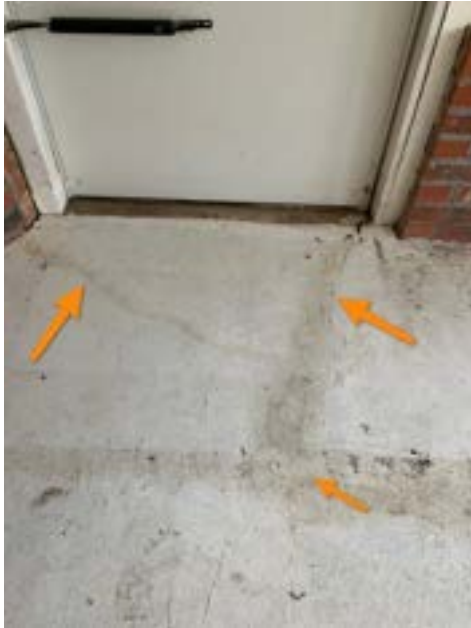
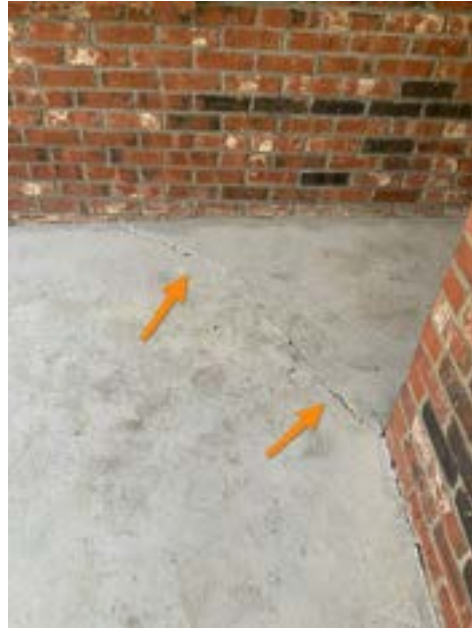
PATIO CRACKING - MINOR

Minor cracking observed on the back covered patio which is normal sign of settling over the years. Recommend a qualified concrete contractor to patch/seal and monitor thereafter.

Contact a qualified concrete contractor.

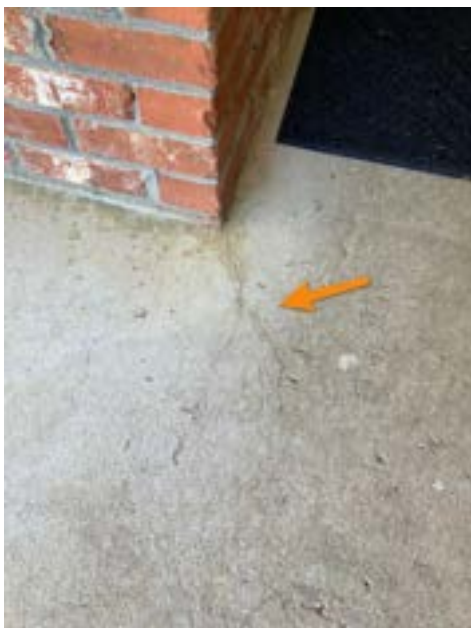
WALKWAY CRACKING - MAJOR

Minor cracks observed which seem to be the result of settling and tree roots growing underneath. Recommend a qualified professional contractor to remove the tree roots and qualified concrete contractor to evaluate and repair all cracks and monitor thereafter.

Contact a qualified concrete contractor.

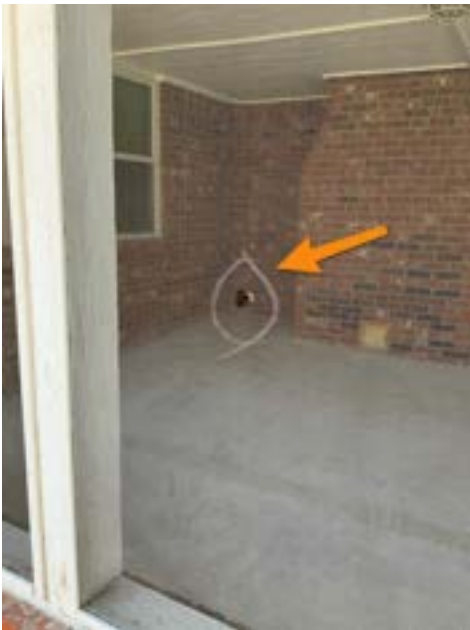
DAMAGED PATIO SCREENING

Observed damaged screening for the covered back patio. Recommend a qualified professional to evaluate and repair all damaged areas.

Recommendation
Contact a qualified professional.

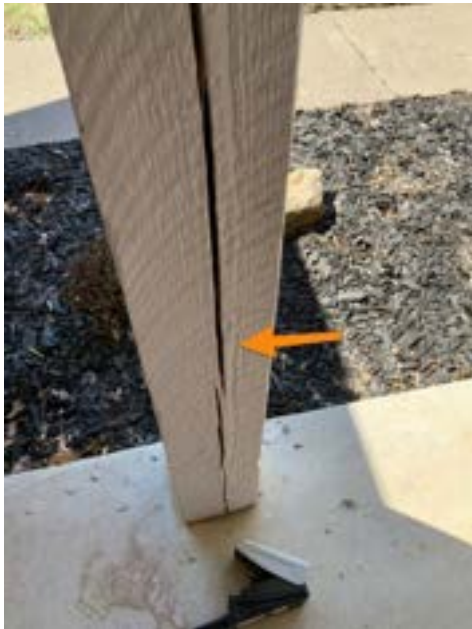
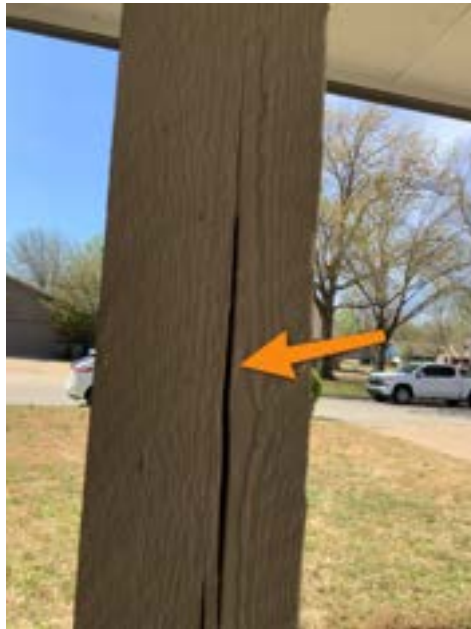
DAMAGED POST

Observed the front porch awning support post damaged/cracked. Recommend a qualified professional to repair or replace post to fix the issue from further damage.

Cracked/Damaged Post

Recommendation
Contact a qualified professional.

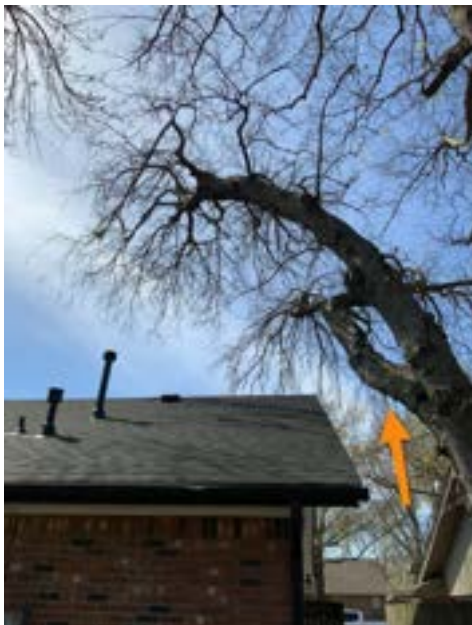
TREE OVERHANG

Trees observed overhanging the roof. This can cause damage to the roof and prevent proper roof drainage. Recommend a qualified tree service or tree removal contractor to trim all limbs to have clearance from the roof to allow for proper drainage and avoid any debris on the roof.

Recommendation
Contact a qualified tree service company.

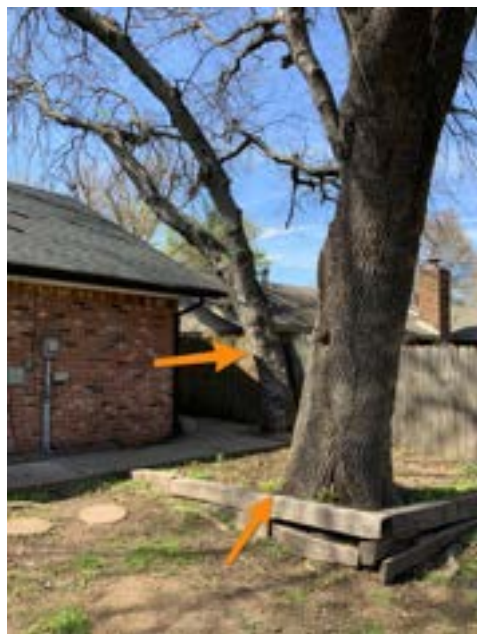
VEGETATION TOO CLOSE

Observed vegetation too close to dwelling. Vegetation too close could cause wear to the siding material and damage the foundation due to roots. Vegetation could also provide pests, and insects a habitat to live in. Recommend a qualified professional or tree service to remove trees/vegetation to allow proper drainage of water and to avoid any unwanted wear or damage to siding and foundation.

Contact a qualified landscaping contractor

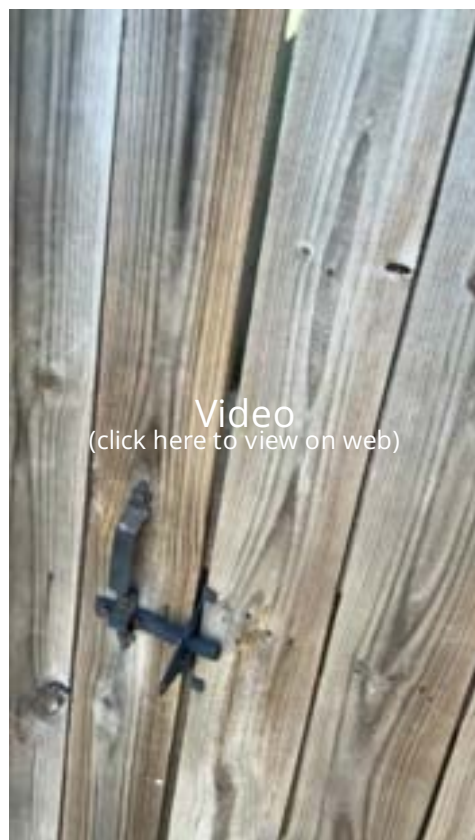
SIDE GATE DEFICIENCIES

Observed northwest side gate entrance to the back yard to be wobbly and not secure. Recommend a qualified professional or DIY to make the sides gate secure and easily accessible.

Contact a qualified professional.

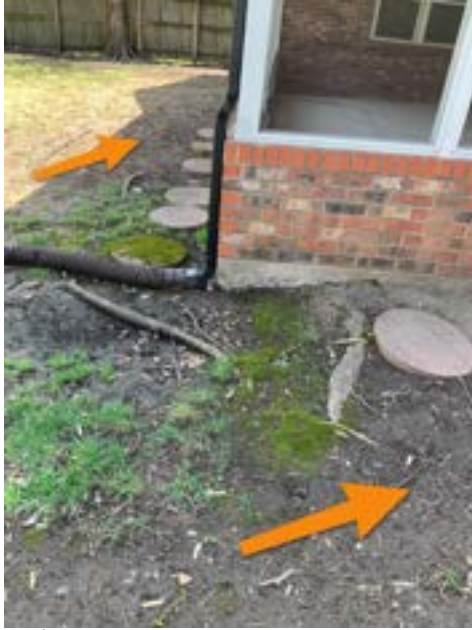
SOIL EROSION

Observed some soil erosion at the exterior east. Recommend a qualified professional to add dirt/topsoil and seed or sod the area to properly grade the area so that water slopes and drains away from the dwelling.

Recommendation
Contact a qualified professional.

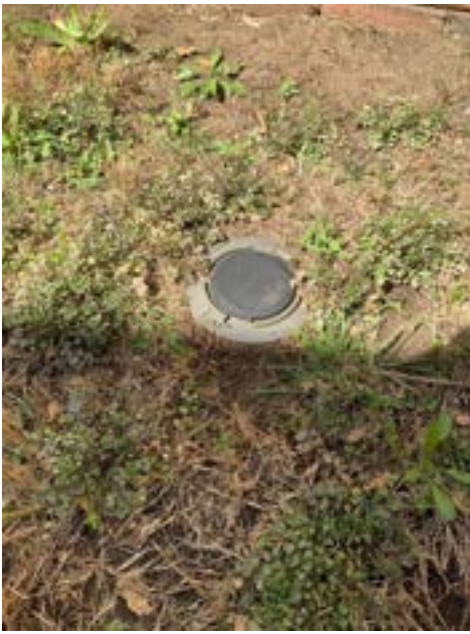
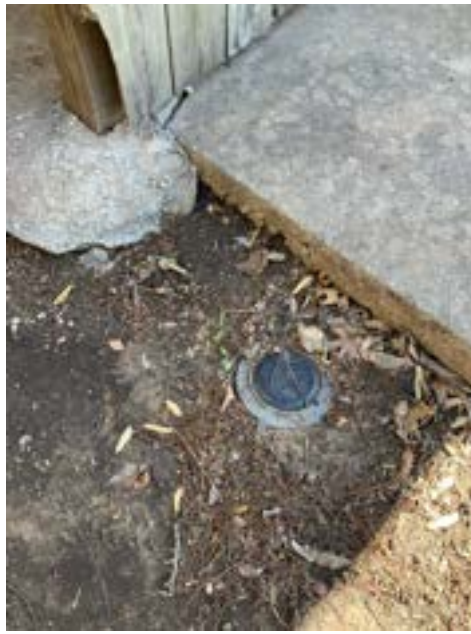
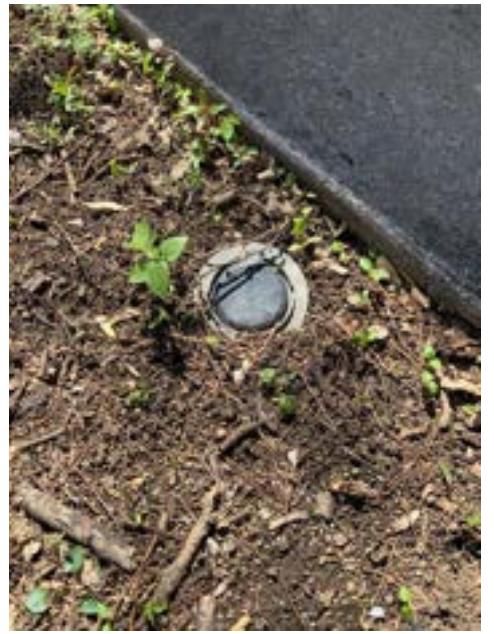
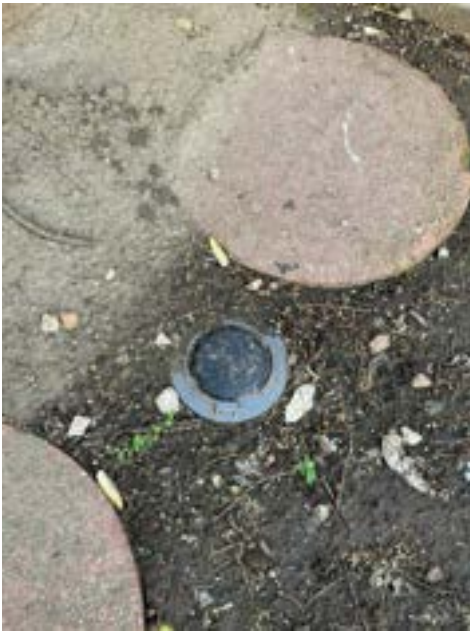
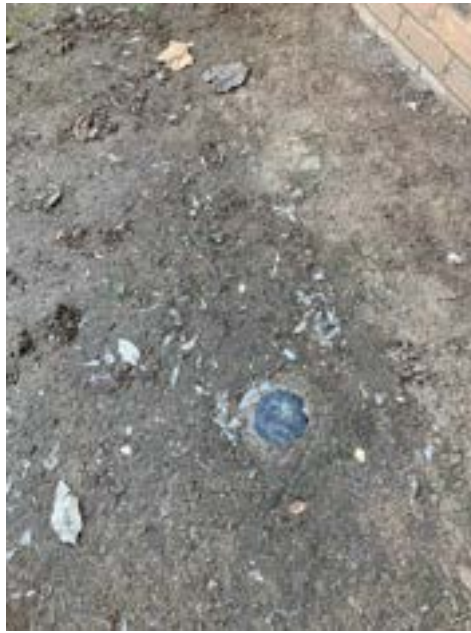
PREVIOUS TERMITE TREATMENT

Observed a bait system for termites which is long term system to kept away termites. Although there were no visible evidence of termites at time of inspection. Recommend to monitor for termites and contact a qualified licensed termite company to evaluate and provide any protective measures with the current system.

Recommendation
Contact a qualified professional.

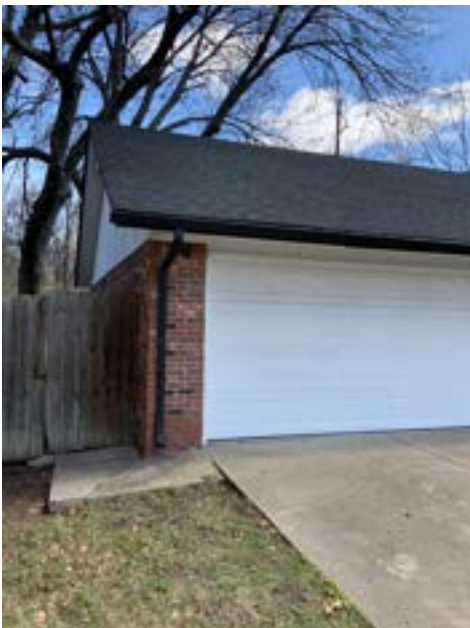
DOWNSPOUTS DRAIN NEAR HOUSE

One or more downspouts drain too close to the home's foundation. This can result in excessive moisture in the soil at the foundation, which can lead to foundation/structural movement. Recommend a qualified contractor to adjust downspout extensions to drain at least 6 feet from the foundation.

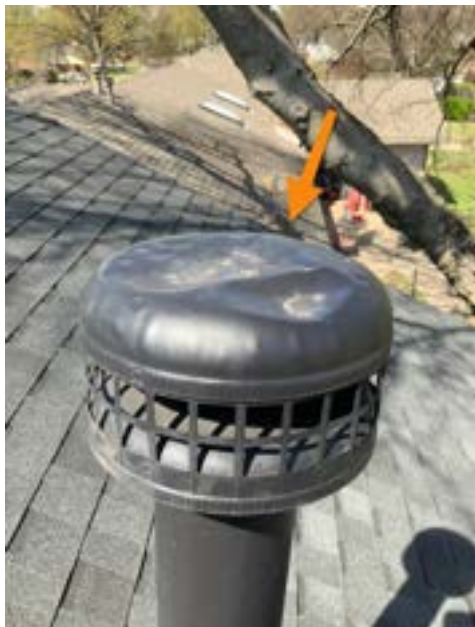
DAMAGED VENT

Damaged furnace and water heater exhaust vent; most likely due to hail, tree debris, or inclement weather. Recommend replacing by a qualified roofing contractor.

Recommendation
Contact a qualified roofing professional.

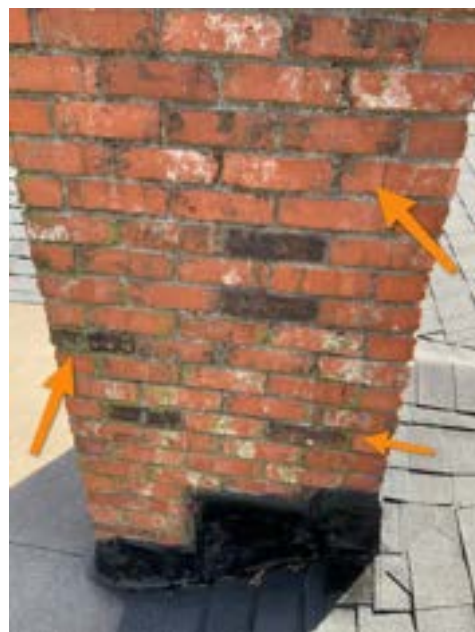
CHIMNEY STACK STAINING

Chimney stack had staining and algae growth. Recommend a qualified professional to clean and remove algae growth.

Recommendation
Contact a qualified professional.

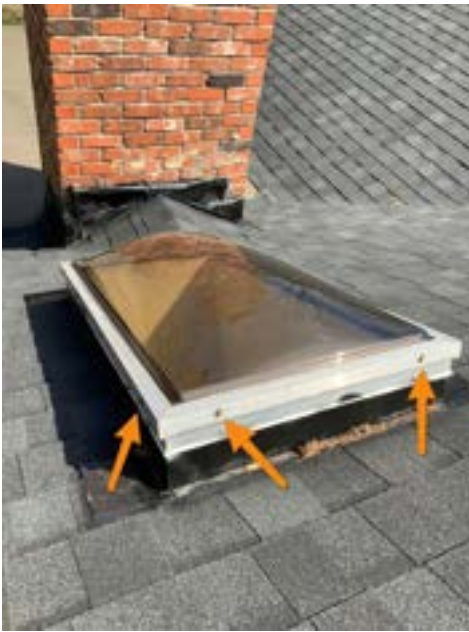
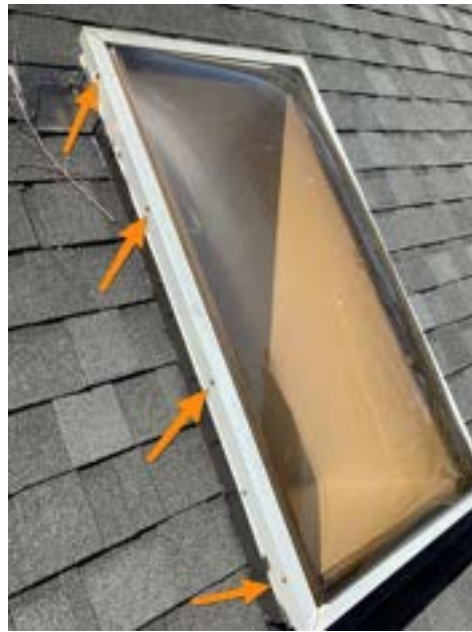
SKYLIGHT RUSTING FASTENERS

Skylight has rusting fasteners which is typical sign of the wrong type of fasteners in place. Recommend a qualified roofing contractor to replace with exterior grade weather resistant fasteners.

Recommendation
Contact a qualified roofing professional.

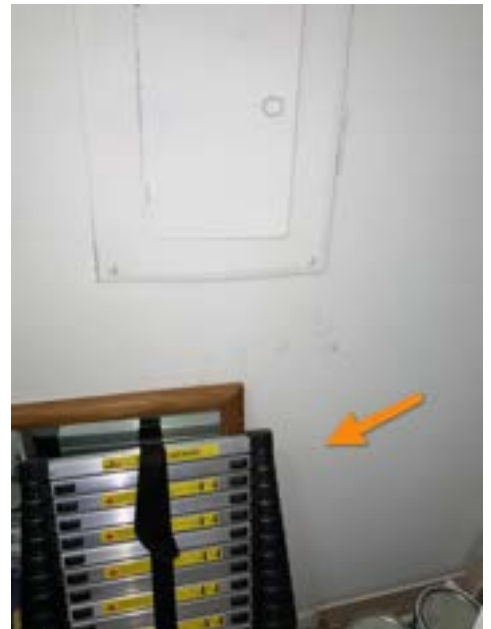
INADEQUATE PANEL CLEARANCE

Electrical code requires a clearance of 3 feet around the electrical panel to ensure accessibility to the panel and wiring. I recommend clearing out area to ensure access to the panel and wiring.

Recommended DIY Project

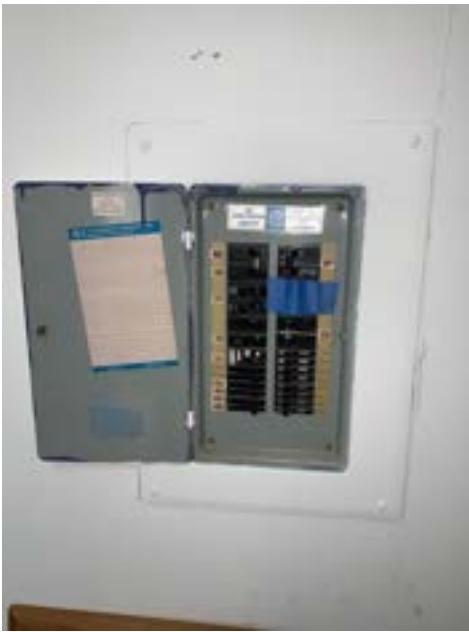
OUTDATED MAIN PANEL

Recommend a qualified licensed electrical contractor to replace and update the main panel with a current model that has a main service breaker for safety standards of code requiring 6 or less "throws" to disconnect all power in case of emergency. On this dwelling there are more than six breakers to disconnect different branches of wiring throughout the house.

Contact a qualified electrical contractor.

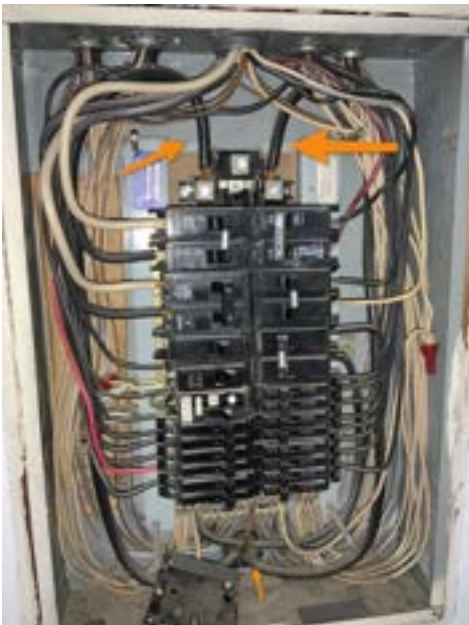
SERVICE AMPERAGE

Observed the service amperage to be at 125amp. The new standard is 200 amp service. With technology ever growing it is wise to determine if this will be enough to suit all electrical needs. Recommend to upgrade to the current standard of 200 amp service by a qualified electrical contractor.

Entrance Conductors 2 AWG

Contact a qualified electrical contractor.

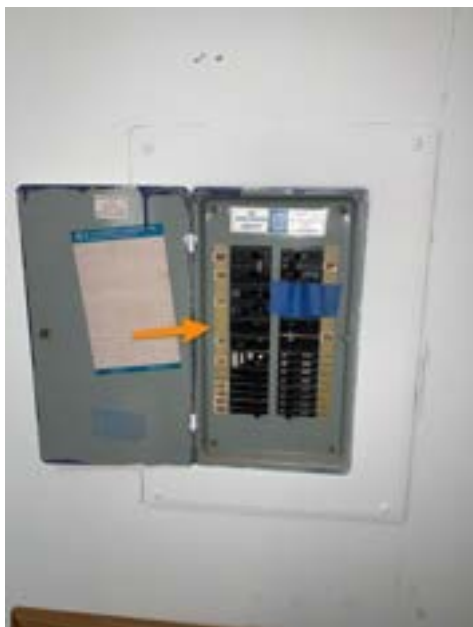
SPARE BREAKERS

Observed 2 spare breakers of which can be old and not working or in place for a spare. Recommend a qualified electrical contractor to test and mark those as spare breakers or remove entirely.

Recommendation
Contact a qualified electrical contractor.

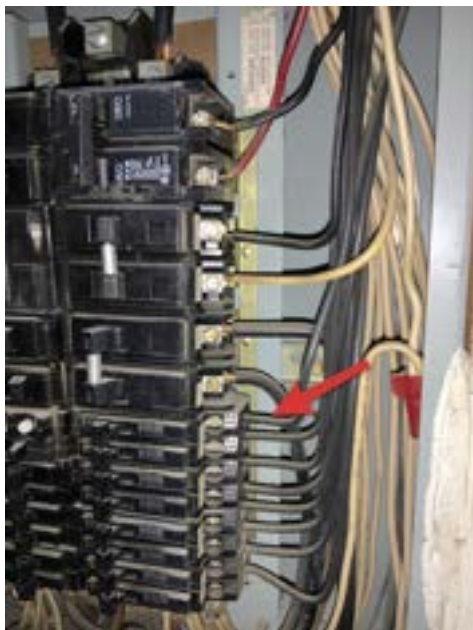
ALUMINUM BRANCH CIRCUITS

Aluminum wire appears to be installed on branch electrical circuits in the electrical panel. These single strand, branch circuit aluminum wires were used widely in houses during the mid 1960s and 1970s. According to the U.S. Consumer Product Safety Commission, problems due to expansion can cause overheating at connections between the wire and devices (switches and outlets) or at splices, which has resulted in fires. For further information on aluminum wiring contact the U.S. Consumer Product Safety Commission via the Internet at <http://www.cpsc.gov/> . It is recommended that the electrical system be evaluated by a licensed electrician and replace all aluminum branch wiring in the home.

Recommendation
Contact a qualified electrical contractor.

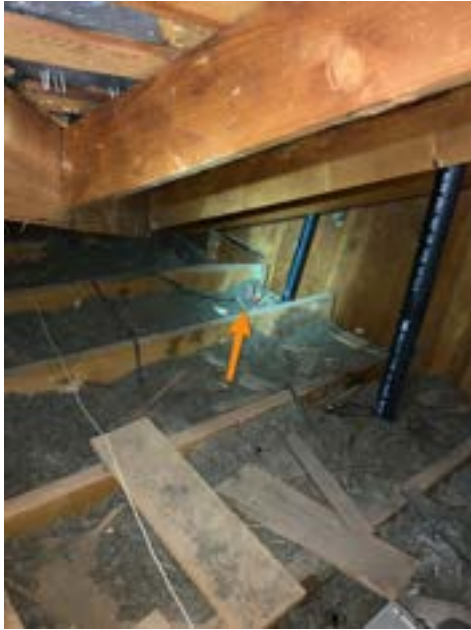
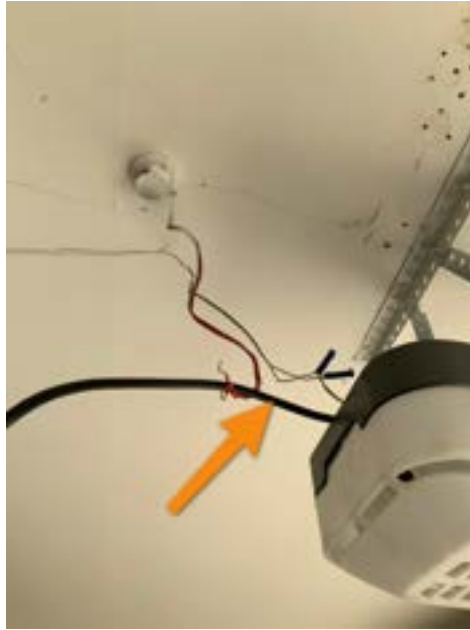
Observed open electrical splices in the attic and garage. All open slices should be joined and contained in a junction box. Recommend a qualified electrical contractor to safely secure all open splices.

Contact a qualified electrical contractor.

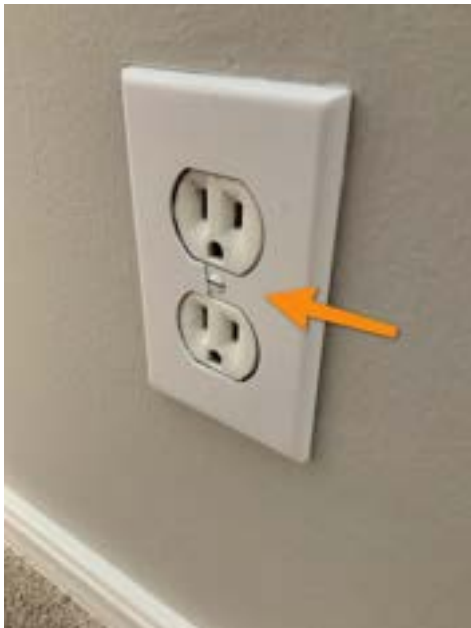
West Bedroom

COVER PLATES DAMAGED

One or more receptacles have a damaged cover plate. Recommend replacement.

Contact a handyman or DIY project

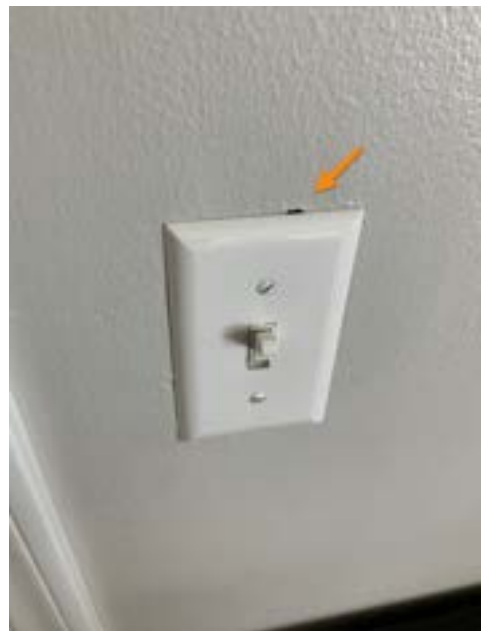
Dining Room Light Switch

Observed gaps in switches/receptacles. Recommend sealing to reduce debris to get inside light switch.

Contact a qualified electrical contractor.

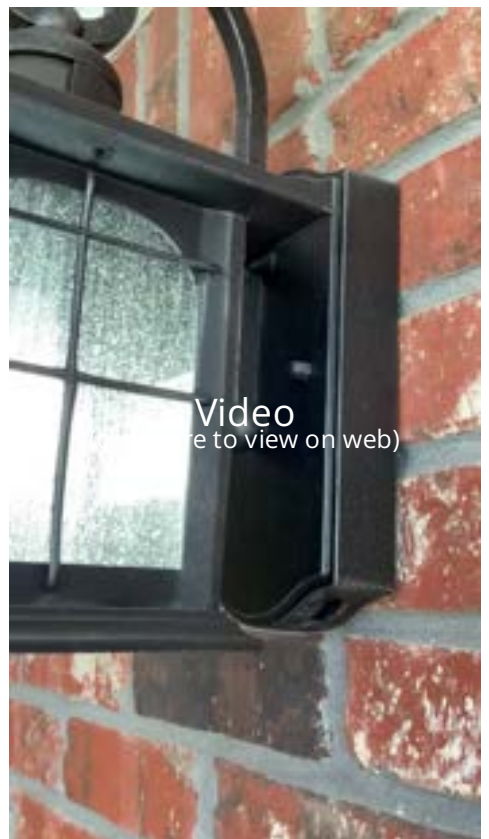
Observed a loose/unsecured exterior light fixture. Recommend DIY or qualified professional to secure and properly seal light fixture since this is an exterior light fixture that's exposed to the elements.

Contact a qualified professional.

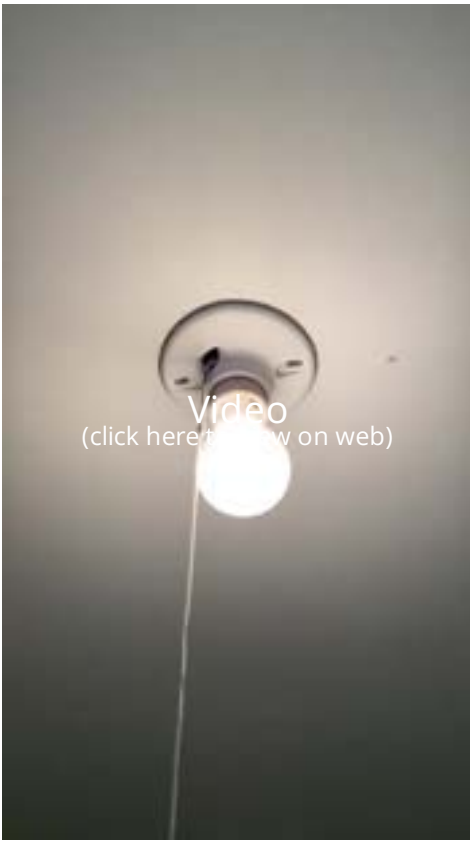
BROKEN PULL SWITCH

The pull switch in the primary bedroom closet did not operate as intended. Recommend a qualified professional to repair or replace the light fixture.

Contact a qualified professional.

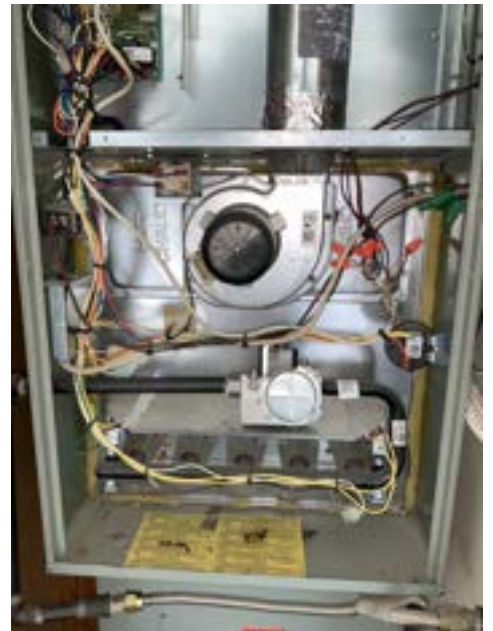
Furnace Manifold

Furnace unit(s) should be cleaned and serviced annually. Observed a dusty and dirty unit by the manifold. Recommend a qualified HVAC contractor to clean, service and certify furnace.

Contact a qualified HVAC professional.

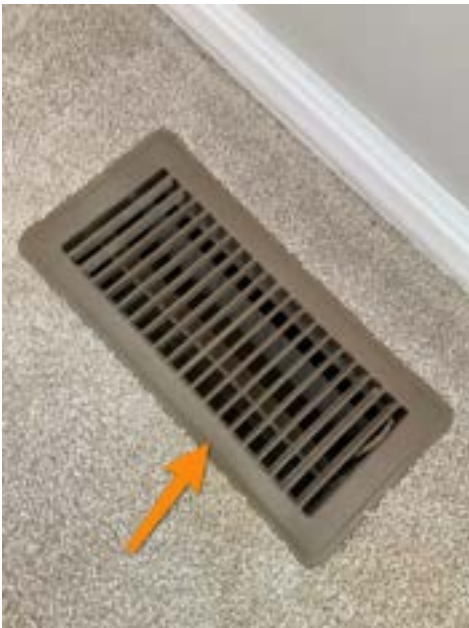
Supply Ducts

Both Return Ducts and Distribution Ducts have dust build up. Recommend a qualified professional to service or clean the ductwork.

Recommendation
Contact a qualified professional.

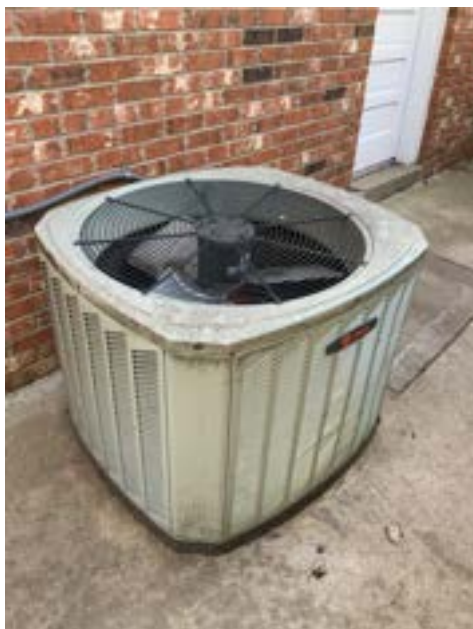
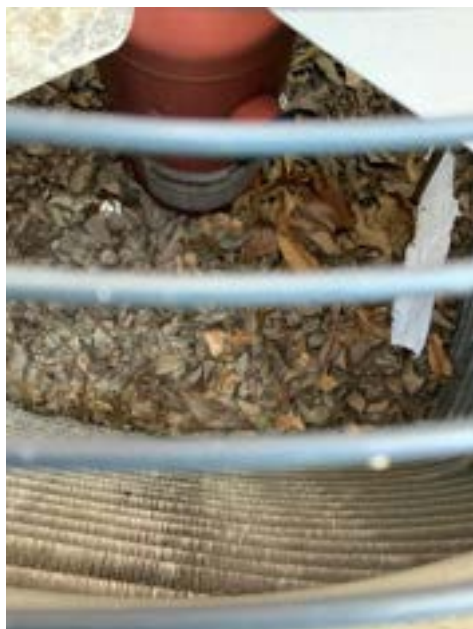
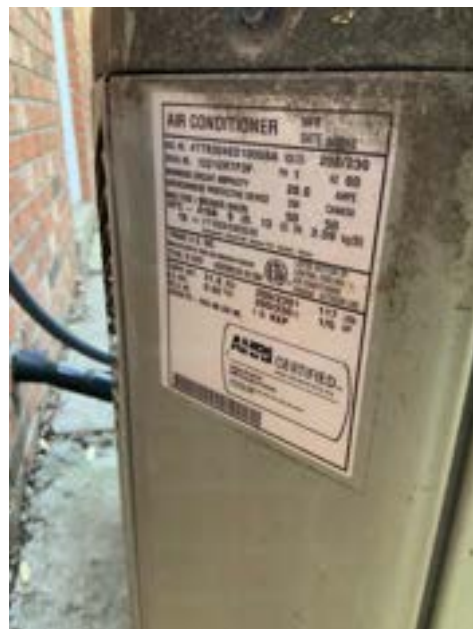
Observed a dirty A/C Condenser unit. Just like the furnace unit the A/C Condenser unit requires annual maintenance. Recommend a qualified HVAC contractor to service/clean the unit to ensure proper function of the unit.

Recommendation
Contact a qualified HVAC professional.

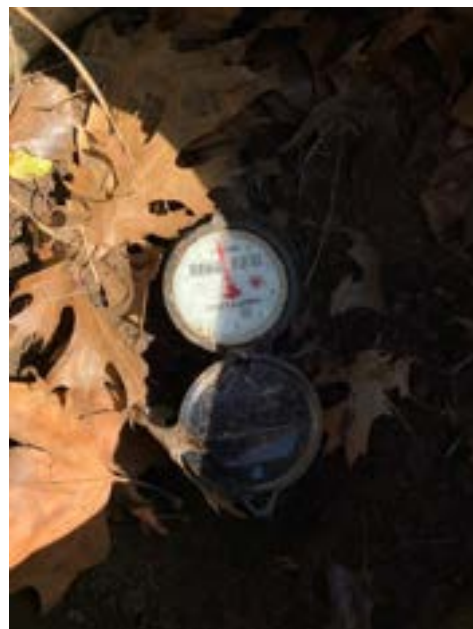
8.1.1 Main Water Shut-off Device **DEBRIS IN WATER METER**

Observed debris in the water meter basin. Recommend cleaning out and removing all debris from meter basin to have appropriate access and function of the water meter.

Recommendation
Contact a handyman or DIY project

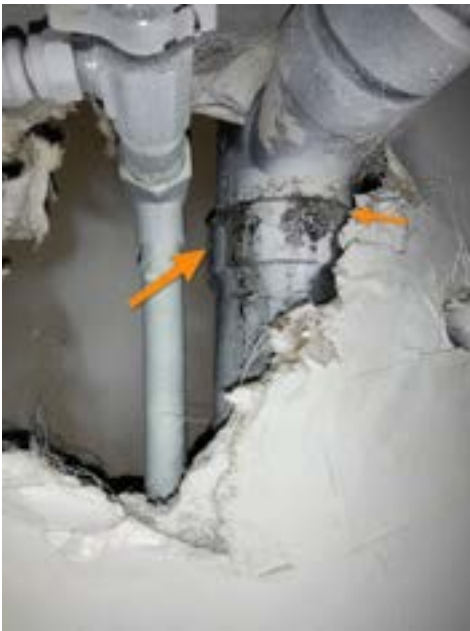
Second Bathroom

8.2.1 Drain, Waste, & Vent Systems **LEAKING SINK PIPE**

An observed leak coming from the drainage pipe after the p trap on the second bathroom sink. Recommend a qualified licensed plumbing contractor to evaluate and repair.

Recommendation
Contact a qualified plumbing contractor.

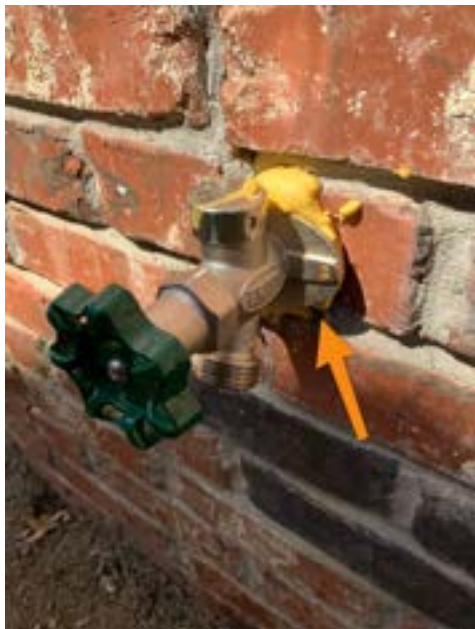
Exterior South

Exterior south and east sillcock or spigot was unsecured. This could result in excessive wear on joints within the walls and cause leaking into the wall or flooring . Recommend a qualified plumbing contractor to secure spigot to the exterior, seal areas with silicone, and to double check for any leaks from the supply line.

Contact a qualified plumbing contractor.

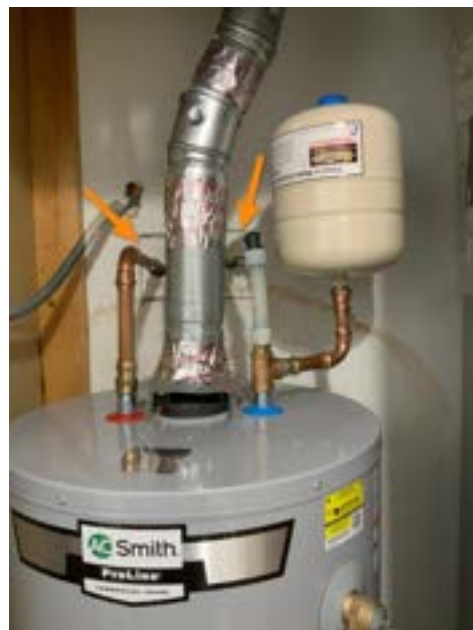
Observed absence of water hammer arrestors. Recommend plumber to evaluate and install if necessary. Water hammer arrestors are required by code on new installs of hot water heaters or where potential water hammering will occur.

No Arrestors

Contact a qualified professional.

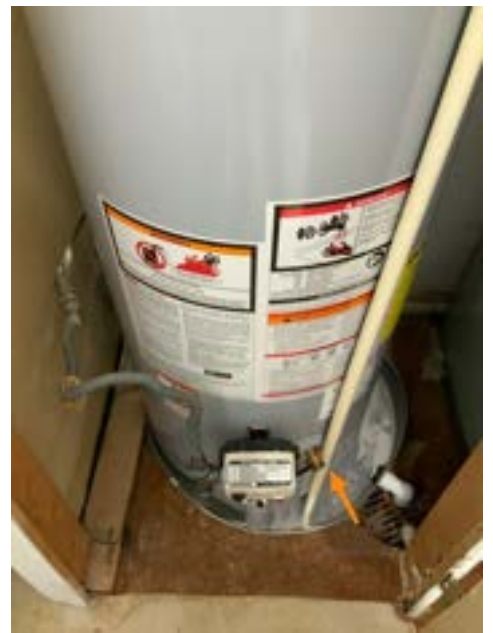
Service Valve

Annual servicing of the water heater tank is required by manufacturer to maintain your water heater so that it ensures it is functioning properly. Recommend a qualified plumber to service the water heater tank if not performed in the last year or is nearing the annual service.

Recommendation
Contact a qualified plumbing contractor.

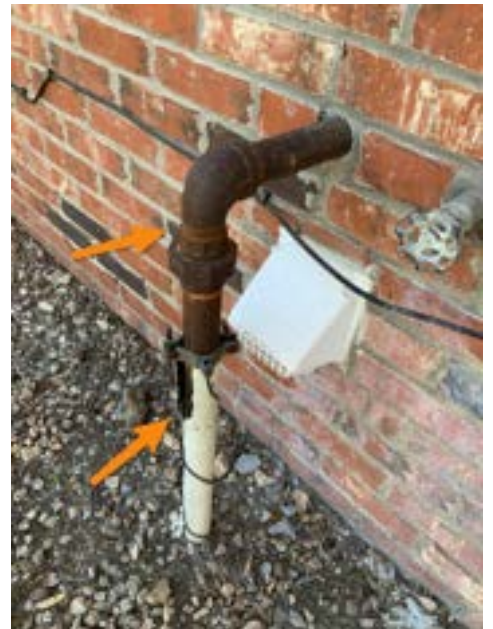
RUSTING GAS PIPING

Gas pipes were rusting which is a sign of corrosion. This can lead to gas leaks. Recommend qualified professional to resurface and reseal/paint gas piping.

Corroded Gas Pipe

Recommendation
Contact a qualified professional.

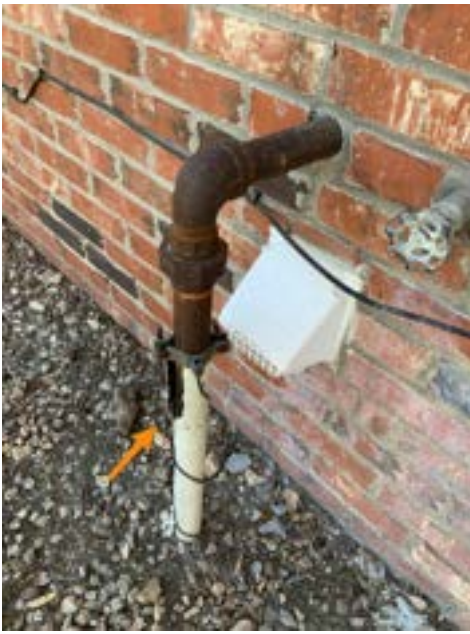
Observed painted gas lines have paint flaking which is common for the age of the home. Recommend resealing to protect against corrosion.

Recommendation
Contact a qualified professional.

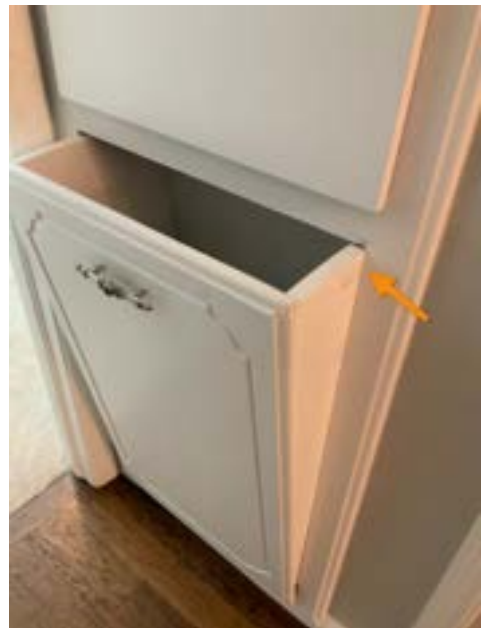
Main hallway linen closet has a bottom drawer that sticks when trying to pullout and does not extend all the way. Recommend a qualified professional to evaluate and repair to ensure proper function.

Recommendation
Contact a qualified professional.

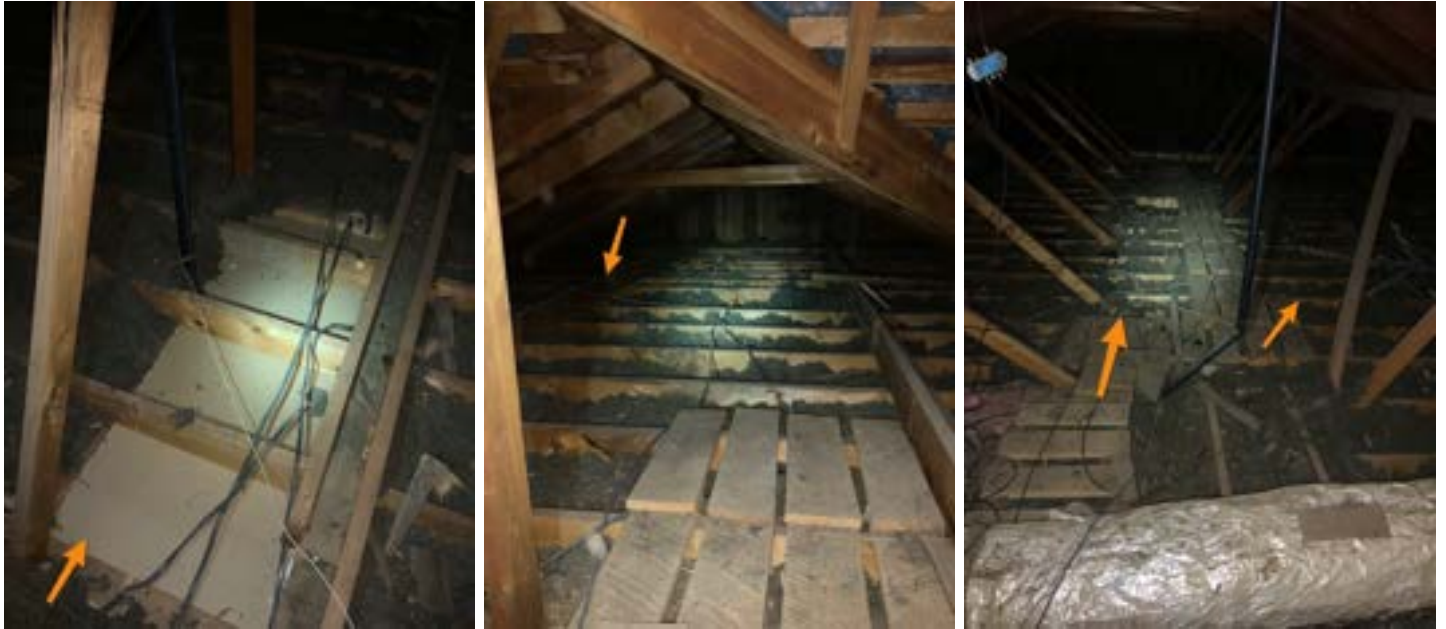
11.1.1 Attic Insulation
INSUFFICIENT INSULATION

ATTIC
 Insulation depth was inadequate. Recommend a qualified attic insulation contractor to remove existing and install additional insulation to meet the current requirements of our zone climate.

Recommendation
 Contact a qualified insulation contractor.

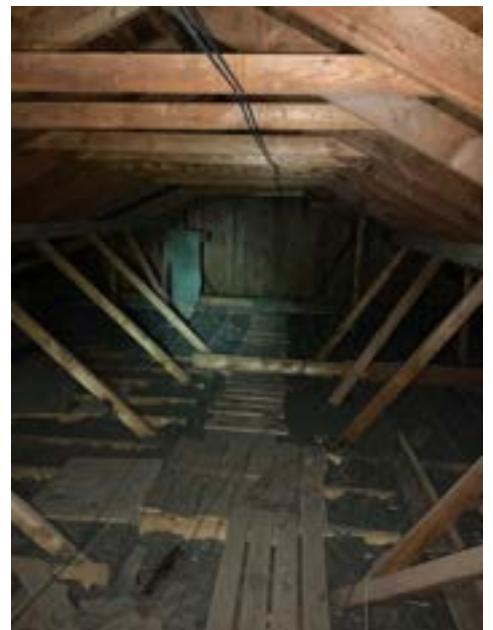
11.2.1 Ventilation
ATTIC VENTILATION INSUFFICIENT

ATTIC
 Attic venting was insufficient at time of inspection. Modern standards recommend 1.5 square feet of venting area for every 300 square feet of attic floor space. Recommend a qualified professional attic contractor to evaluate and ensure there is adequate ventilation for the attic space.

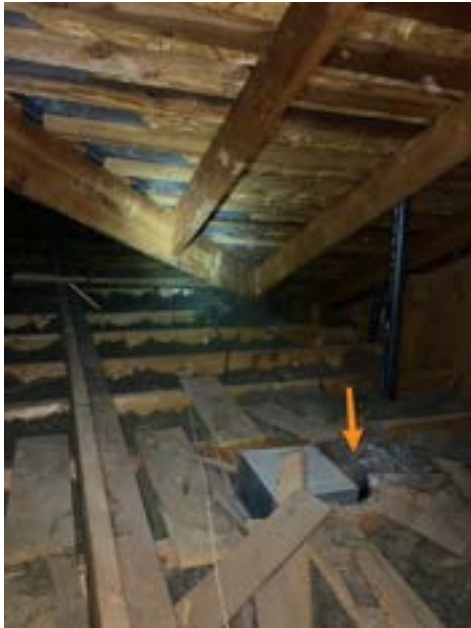
Primary Bathroom Exhaust Fan

11.3.1 Exhaust Systems
BATHROOM VENTS INTO ATTIC

Bathroom fan vents into the attic, which can cause moisture and mold. Recommend a qualified attic/HVAC contractor to properly install exhaust fans that terminate to the exterior.

Recommendation
Contact a qualified HVAC professional.

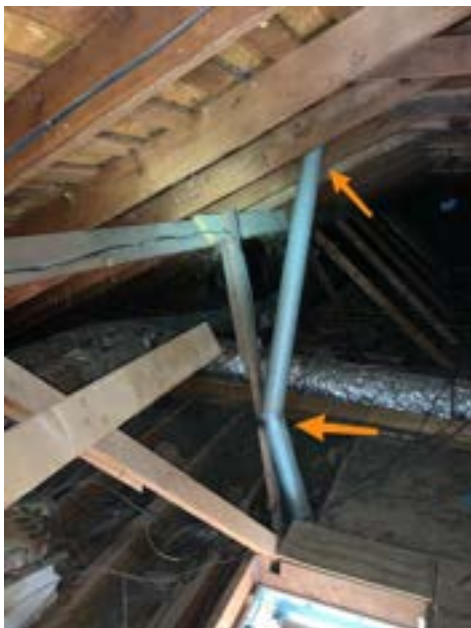
Stove Exhaust Duct

STOVE EXHAUST DUCT DAMAGED

The stove exhaust duct is not properly supported, sealed, and terminated to the roof exterior. Recommend a qualified licensed HVAC contractor to evaluate and repair or replace.

Recommendation
Contact a qualified professional.

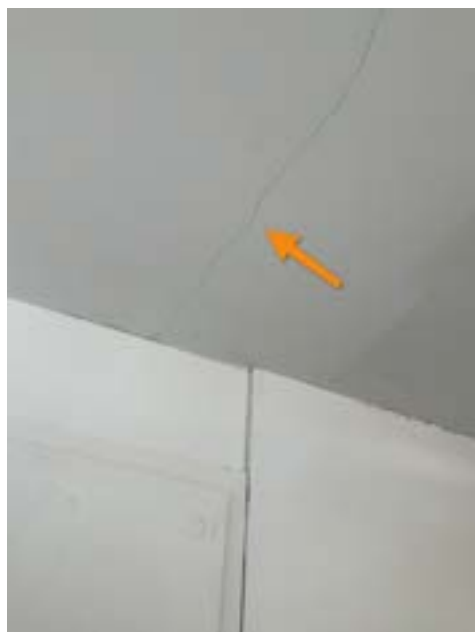
Garage Ceiling

Garage ceiling has cracking that is not aligned with a drywall seam and may be the result of settling or improper use of the attic space. Recommend a qualified drywall contractor to evaluate and repair to have a good starting indicator for any signs of active settling.

Contact a qualified drywall contractor.

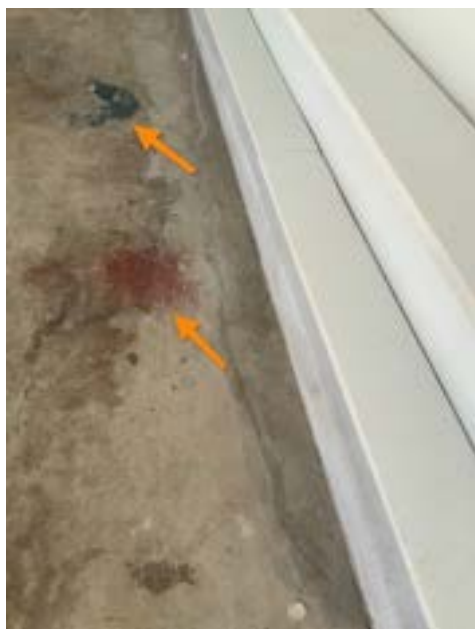
Garage Floor Staining

STAINING

Garage floor shows visible staining from oil/grease. Recommend scrubbing with a degreaser or cleaning solution.

Contact a handyman or DIY project
