SUMMARY

Tulsa, OK 74133

Noe Vazquez
OK License #70002512
Welcome Home Inspections LLC
5393451569
welcomehomeinspectionsok@gmail.com

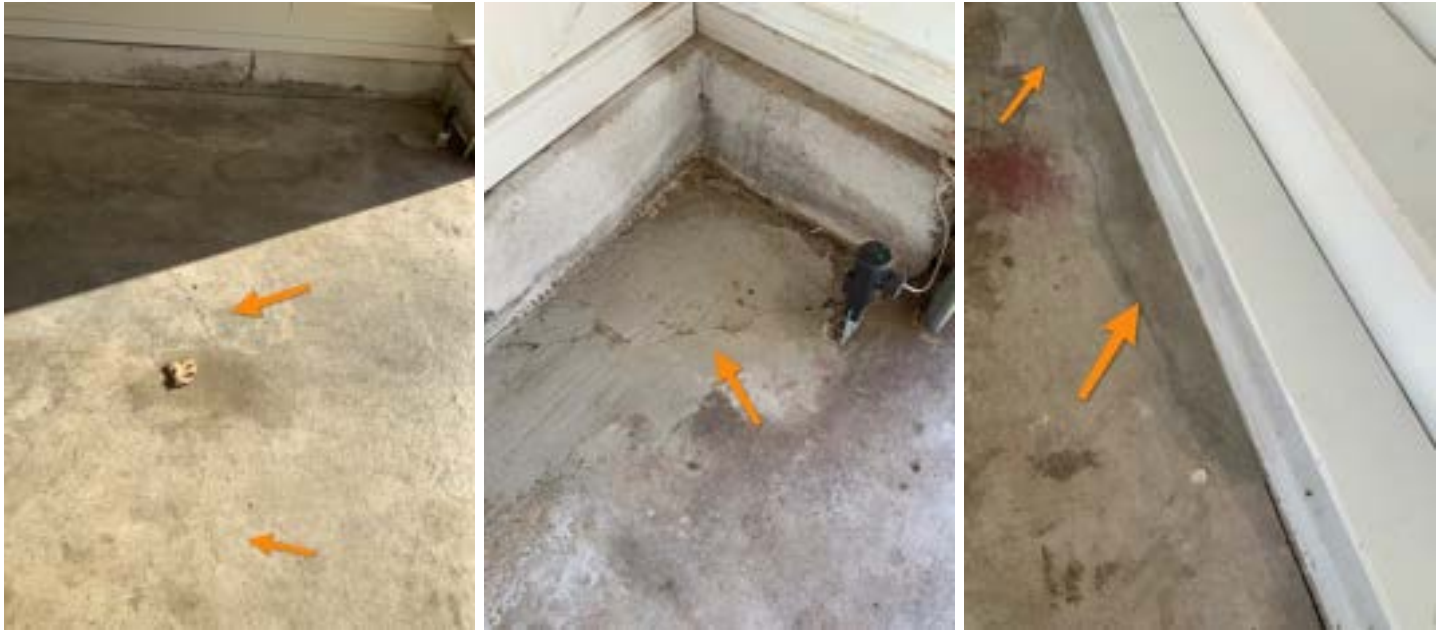
CRACKING-MINOR

Observed minor cracking on the garage floor. Recommend a qualified concrete contractor to evaluate and repair cracking. After repair recommend monitoring for any settling/ movement as this could be a sign of structural concerns.

Recommendation
Contact a qualified concrete contractor.

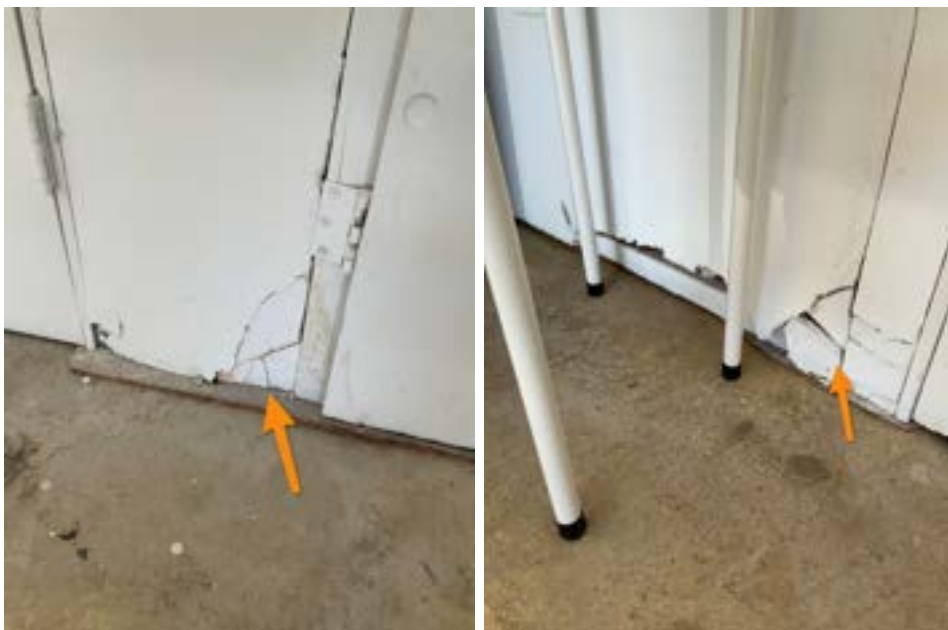
12.3.1 Walls & Firewalls **DAMAGED DRYWALL**

Garage wall had damaged drywall. Recommend a qualified professional drywall contractor repair all damaged drywall in the garage.

Damaged Drywall

Recommendation
Contact a qualified drywall contractor.

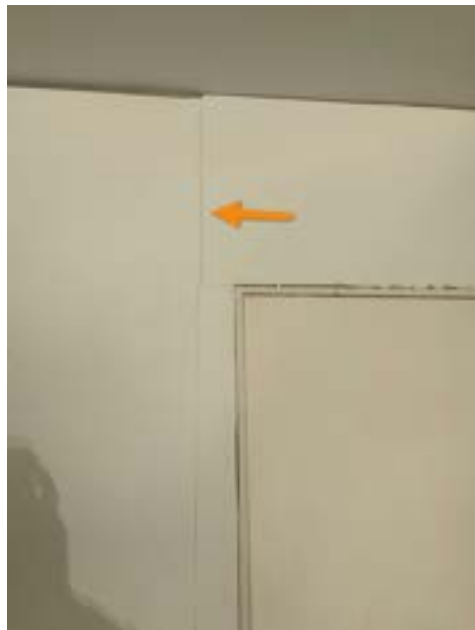
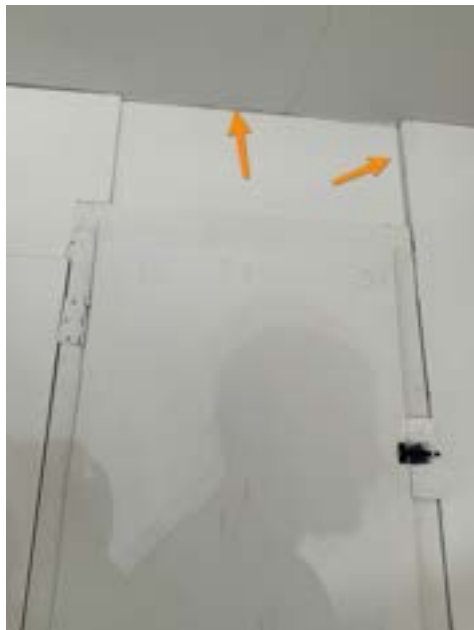
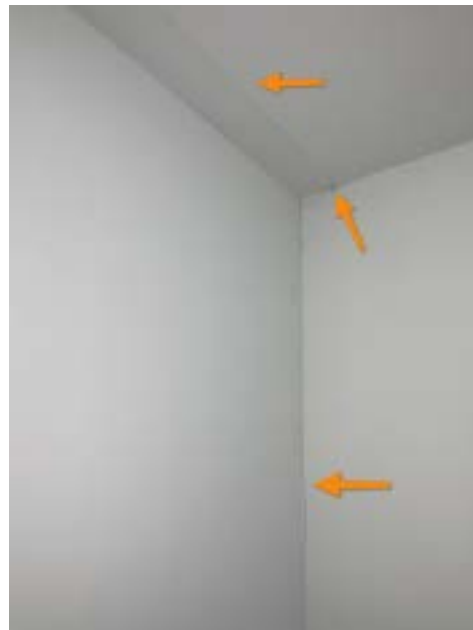
Visible drywall seams in garage. I recommend a qualified drywall contractor to fix this issue and monitor for any water intrusion or structural movement.

Contact a qualified professional.

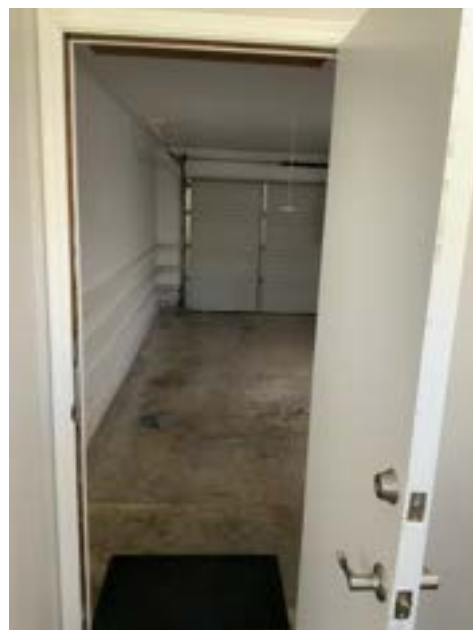
Door from the garage to the home should have self-closing hinges to help prevent spread of a fire to the living space. Recommend a qualified contractor to install self-closing hinges.

Contact a handyman or DIY project
